CELLAR to CHIMNEY
Home Inspection Services LLC

Inspection Report

Property Address:
2375 W. Meadowbrook Lane
Waukesha WI 53103

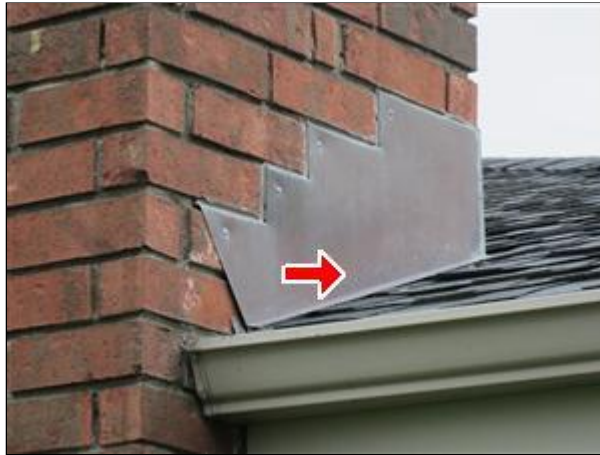
1.1 This home is equipped with copper flashings for both of the chimneys.

1.1 Picture 1 Copper Flashings

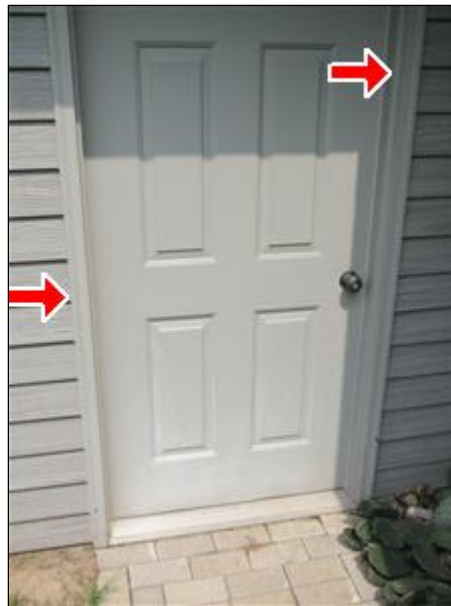
2.2 The trim for the service store of the garage should be painted.

2.2 Picture 1 Paint Service Door Trim

Lead was banned for use a component of residential paint in 1978. Any substrate or surface painted, stained or varnished prior to 1978 may contain lead. Disturbing these surfaces may release lead dust which is harmful, toxic and can cause serious illness.

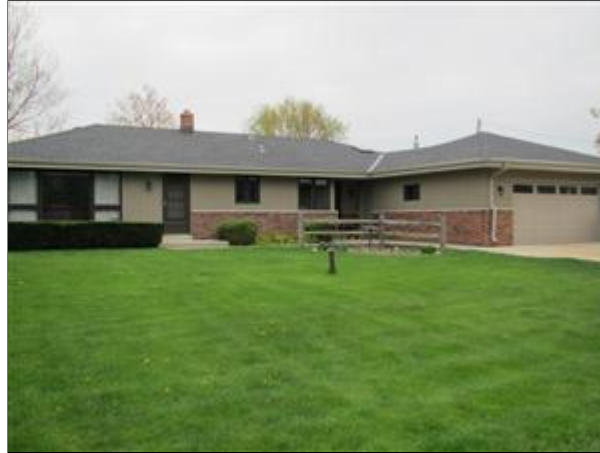
Front Yard

3.0 A drainage swale has been installed around the south side of the property which appears to have been very effective in preventing any kind of moisture intrusion into the basement.

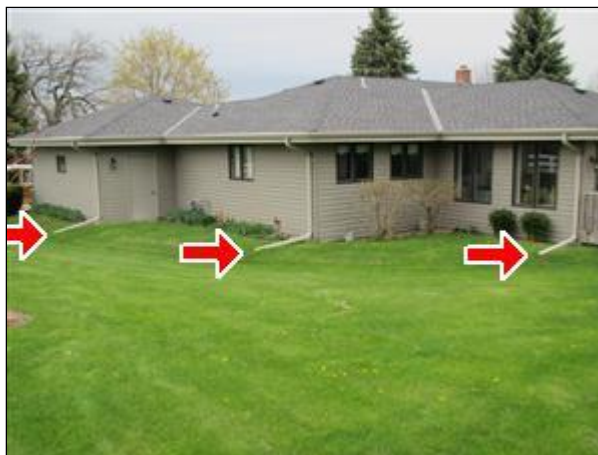
3.0 Picture 1 Drainage Swale

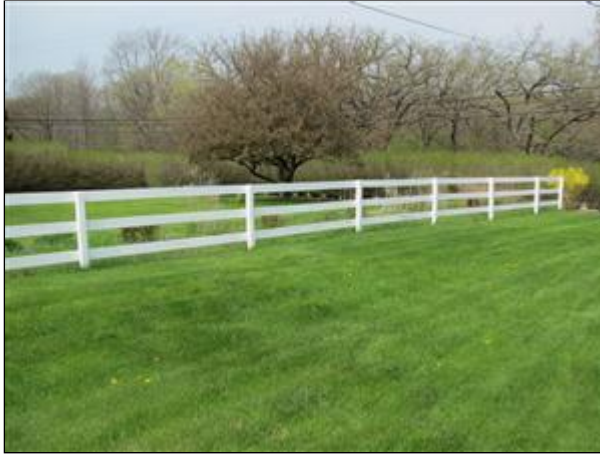
3.4 Picture of the wood plank fence on the west side of the property.

3.4 Picture 1 West Side Fence

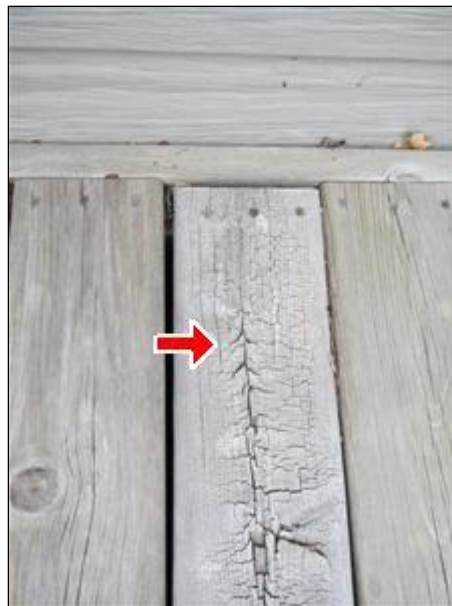
4.3 This deck board towards the edge of the deck is warped creating a trip hazard. Recommend replacing this board.

4.3 Picture 1 Warped Deck Board

- This deck board towards the edge of the deck is warped creating a trip hazard. Recommend replacing this board.

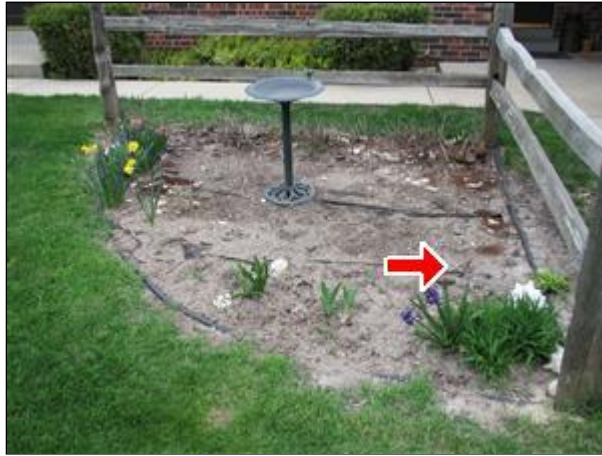
5.1 I checked the holding tank's cover to be sure it was intact and secured. The inside of the tank should be inspected once it is pumped. The plumber will be looking for any signs of tank deterioration, whether the baffle is loose or inappropriately installed and he will check to be sure water from the home easily enters the tank through the sewage pipe.

5.1 Picture 1 Holding Tank Cover Buried Here

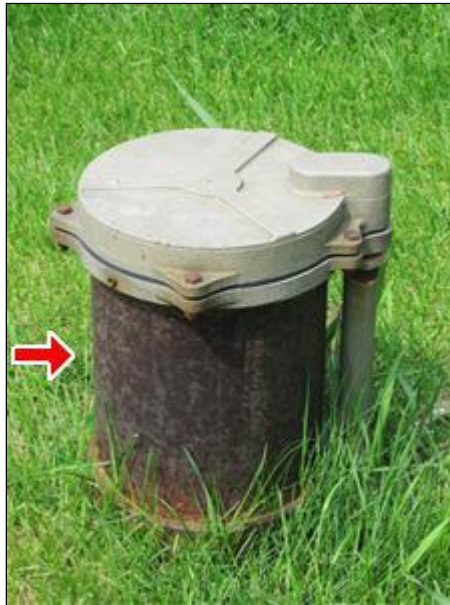
Well Case

6.4 Only the outside areas of the well case visible above the ground have been inspected. To determine if there are any cracks or structural problems with the well case consult a professional well driller.

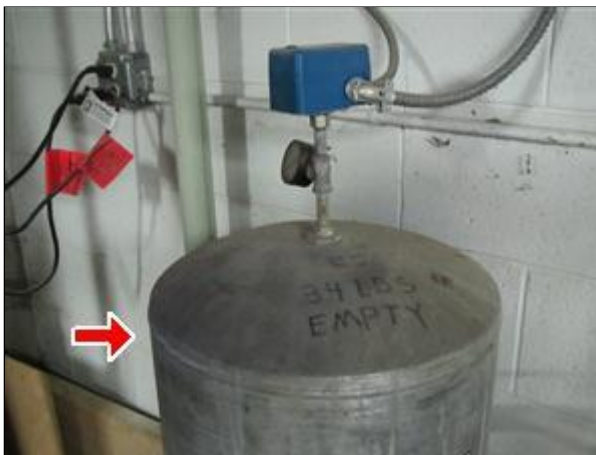
6.0 Picture of the well's pressure tank.

6.0 Picture 1 Pressure Tank

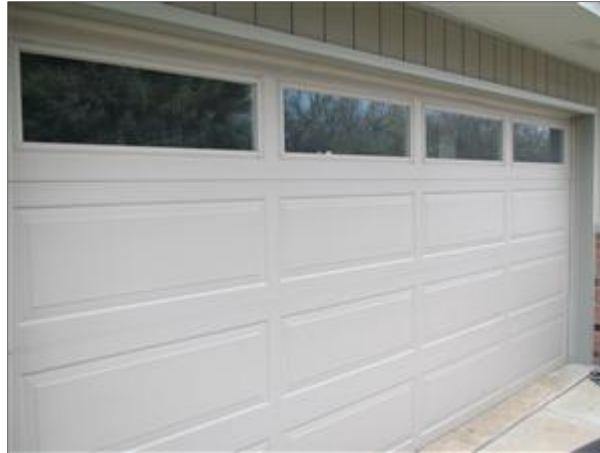
Garage

7.6 There was some slight spalling noted on the garage floor which can be pretty typical for Wisconsin.

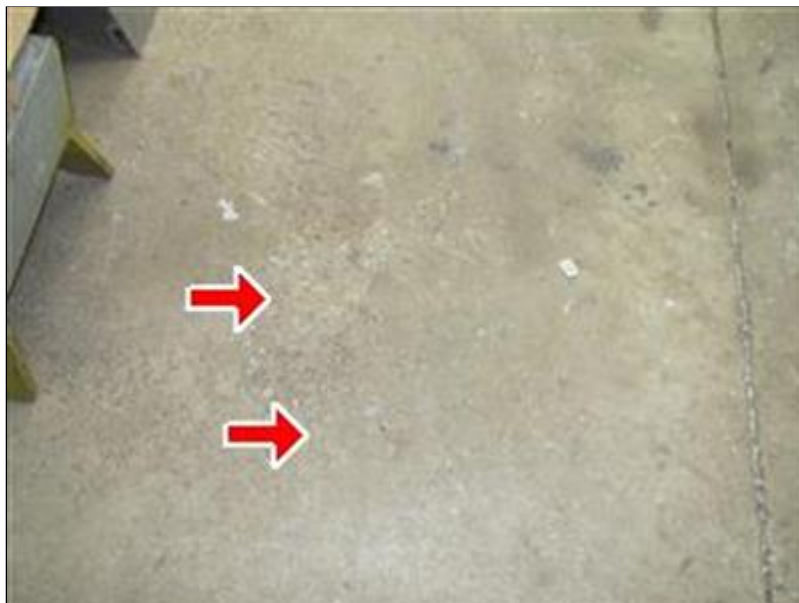
7.6 Picture 1 Spalling On Garage Floor

- There was some slight spalling noted on the garage floor which can be pretty typical for Wisconsin.

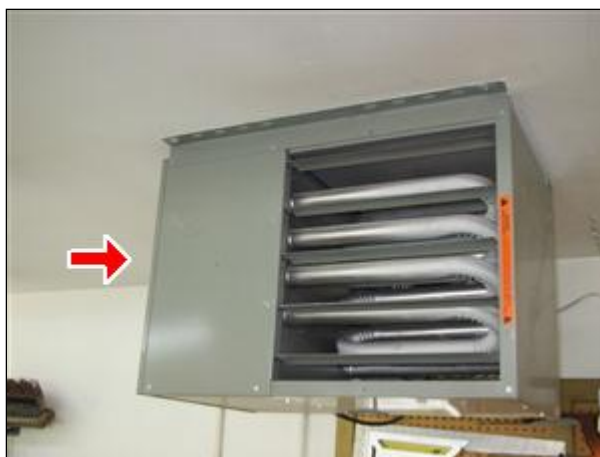
7.11 The garage is equipped with a professionally installed ceiling mounted gas furnace. The furnace was operating properly at the time of the inspection.

7.11 Picture 1 Gas Furnace in Garage

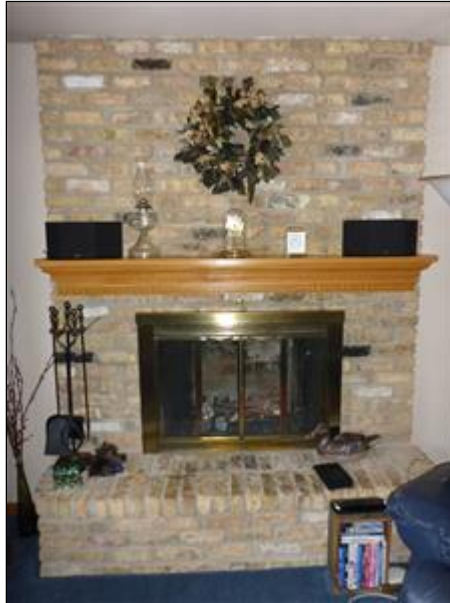
Fireplace

10.2 The fireplace flue is excessively dirty. An accumulation of soot and other materials can result in a chimney flue fire. There is also the possibility that soot, dirt, and cobwebs concealed other problems or defects; concealed defects are not within the scope of the home inspection. Recommend having flue and/or damper cleaned and inspected by a licensed chimney professional before use.

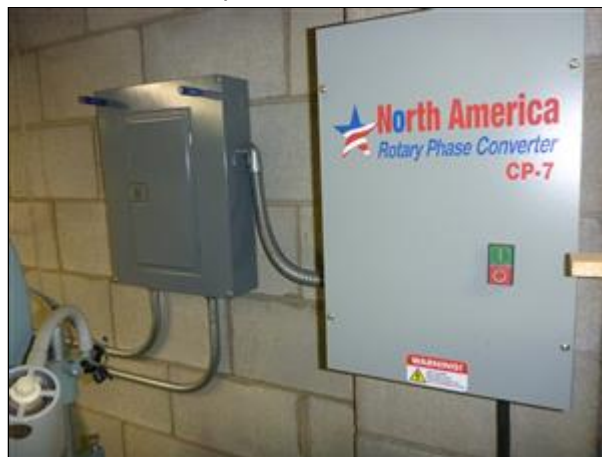
13.8 This home is equipped with a three phase rotary converter electrical system to power equipment in the basement shop. The system was functional at the time of the inspection.

13.8 Picture 1 Three Phase Converter Panel And Distribution Panel

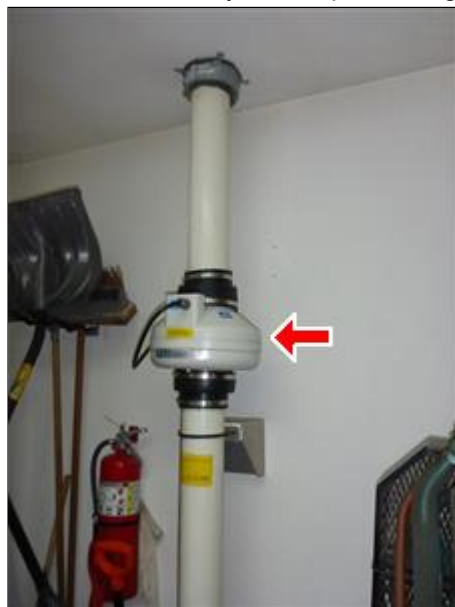
14.12 The home is equipped with a radon mitigation system. The system was operational at the time of the inspection. I recommend a radon test to be sure the system is performing as required.

14.12 Picture 1 Radon Fan

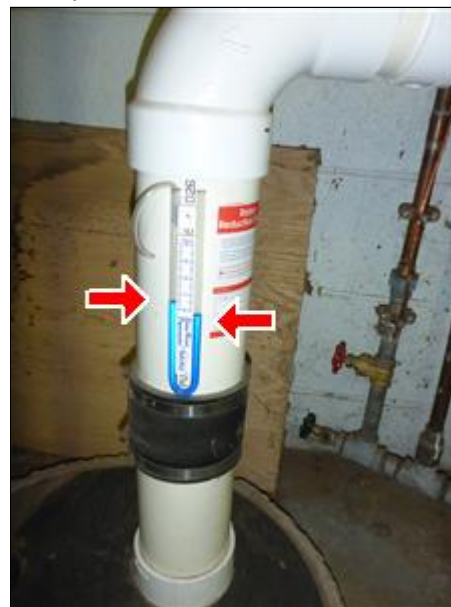
14.12 Picture 2 Vacuum Gauge For Radon System

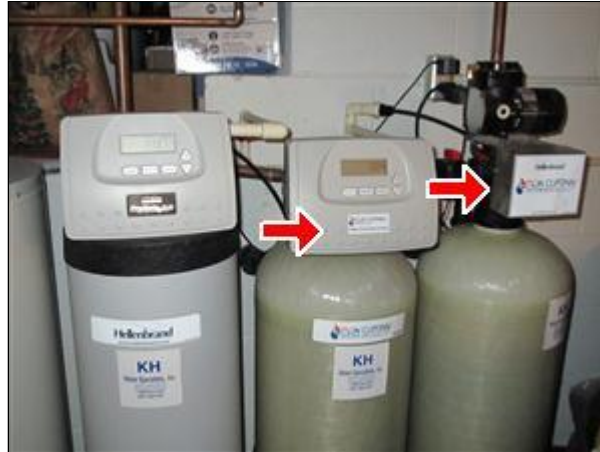
15.4 The iron filter was inspected for proper installation. A functional test of the iron filter should include a water test for iron levels and running the unit through all the wash cycles. Testing should be performed by a licensed plumbing contractor.

15.4 Picture 1 Picture Of The Iron Filter

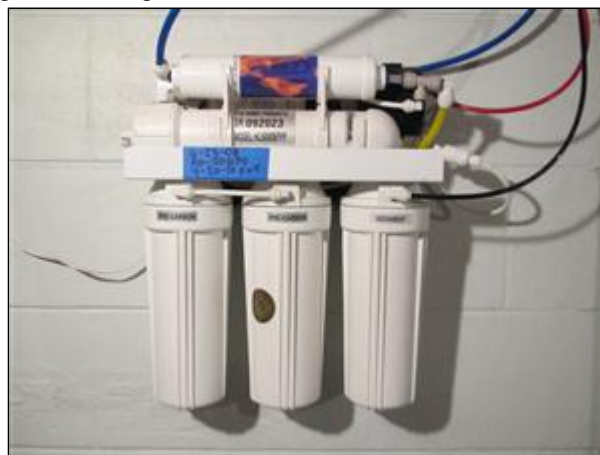
15.6 The reverse osmosis filter was inspected for proper installation. If it has not been done in the last two years, the RO unit should have all the filters changed including the membrane.

15.6 Picture 1 Reverse Osmosis System

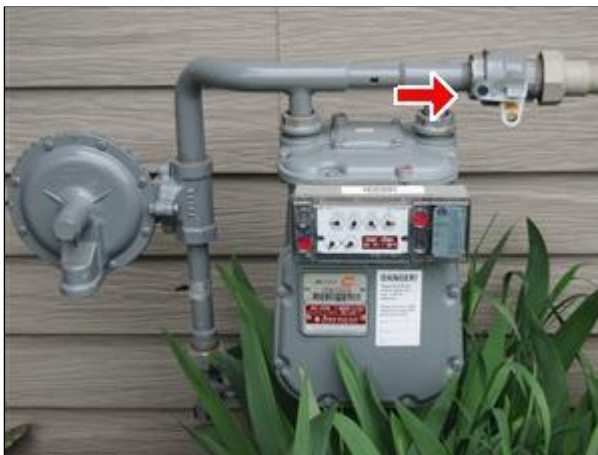
15.7 Gas meter with shut-off indicated by the arrow.

15.7 Picture 1 Main Gas Shutoff Valve

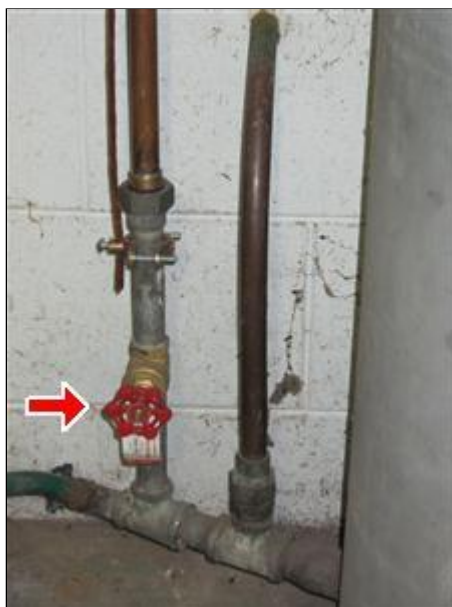
15.8 Picture of the main water shutoff valve located in the southeast corner of the basement.

15.8 Picture 1 Main Water Shutoff
Valve

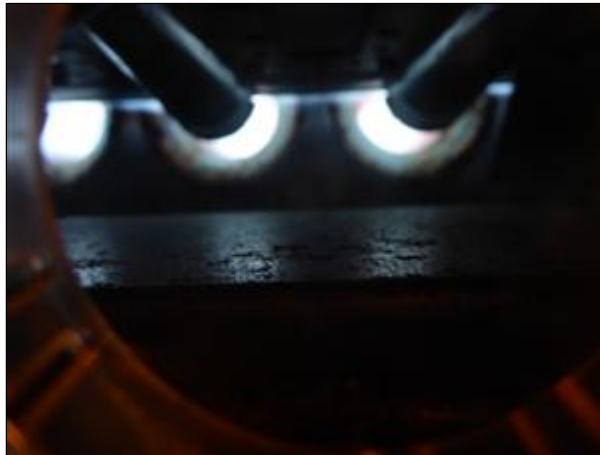
Blue Burner Flames – Good

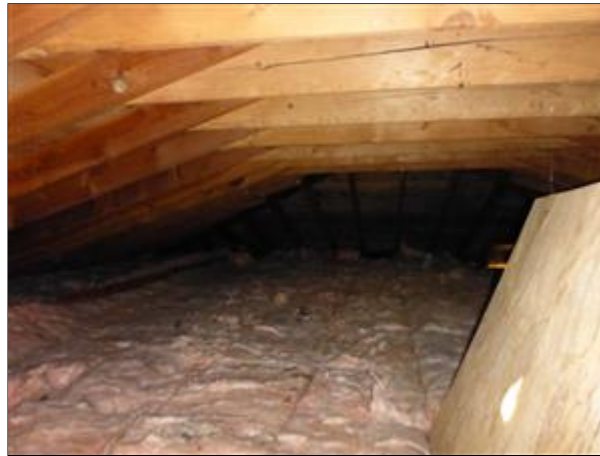
Attic

18.7 No insulation was installed on the attic scuttle hole cover. Suggest installing weatherstripping and foam insulation on the cover to make it more energy efficient.
